Client Help Sheet

Green Goo

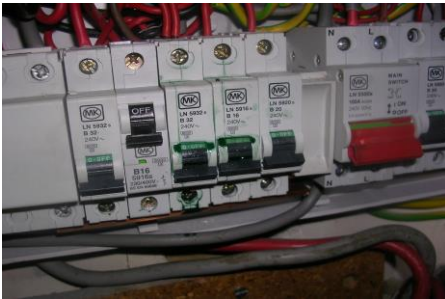
Goo leaking from a Consumer Unit.

Those who are suffering from the effects of Green Goo in your property will notice the dark green substance seeping out of switches and sockets, it looks somewhat like Fairy Liquid and is tacky to touch, in some cases it is not so obvious and will remain unnoticed until some electrical work is carried out, in the most severe cases you will find it dribbling down the wall beneath your electrical outlets.

The bottom line is it is a fault of the manufacturing practice that was employed in the making of early PVC cable. Without getting too technical and discussing the makeup of PVC (polyvinyl chloride) what you need to understand is that PVC requires a plasticiser to be added in order to make it pliable to use in cables, the early plasticisers reacted with the copper in the cable when it reached a given temperature.

If we look at the electrical installation first, then it is fair to say that a lot depends on the loading and usage. The warmer the conductors (cables) get the more the plasticiser leaches, this can result in the cable becoming brittle and eventually breaking down.

Unfortunately if an installation is seriously affected then the only real solution is to have the installation completely rewired. Simply replacing outlets/accessories will only serve as a temporary aesthetic solution, as the underlying problem still exists.

If you have concerns about your property then a simple insulation resistance test can be carried out by a qualified electrician this will tell you to what extent your cable has or has not deteriorated.
